PRE-CERCLIS SCREENING ASSESSMENT CHECKLIST/DECISION FORM

Site Name: South Cherokee Street Creek Site

SOUTH CHEROKEE STREET CREEK SITE

PHOTO DOCUMENTATION

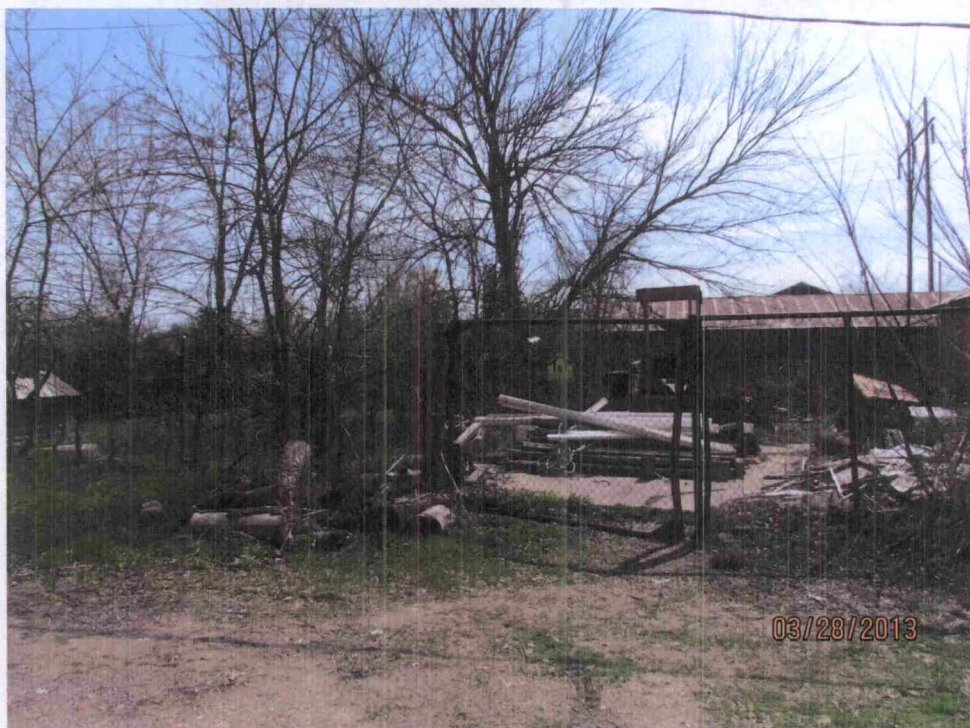
Photo # 1

Comments: View of site showing metal, plastic, woody debris, and rusted machinery behind north gate on east side of building. Note bent gate and wood pile outside gate. Metal building in background is part of adjacent business.

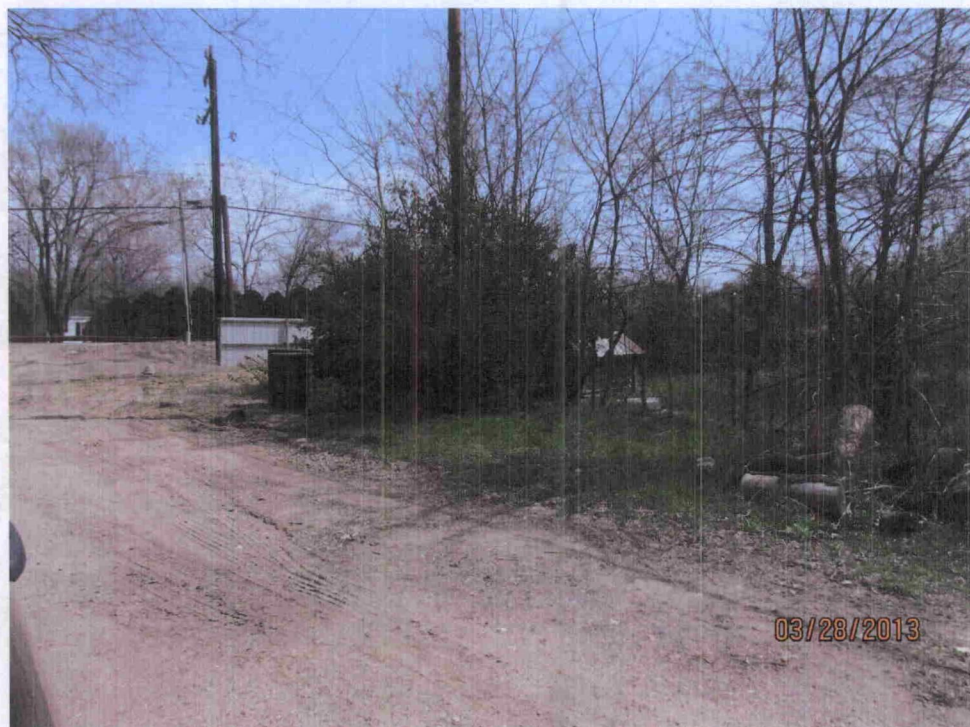
Photo # 2

Comments: View showing wood pile on right and residence on left side behind evergreen hedge east of site and South Cherokee Street. Coody Creek is immediately left of photo.

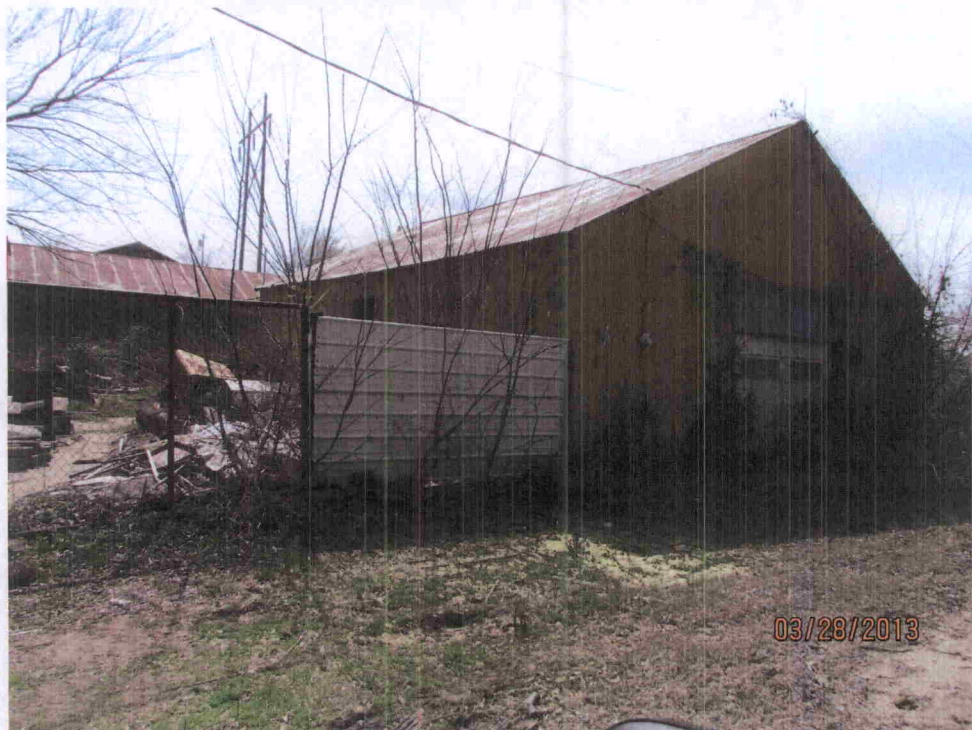
Photo # 3

Comments: View of building, showing woody and vining vegetation growing through fence and up the side of building. Note various piles of debris behind fence. Contents of building are unknown.

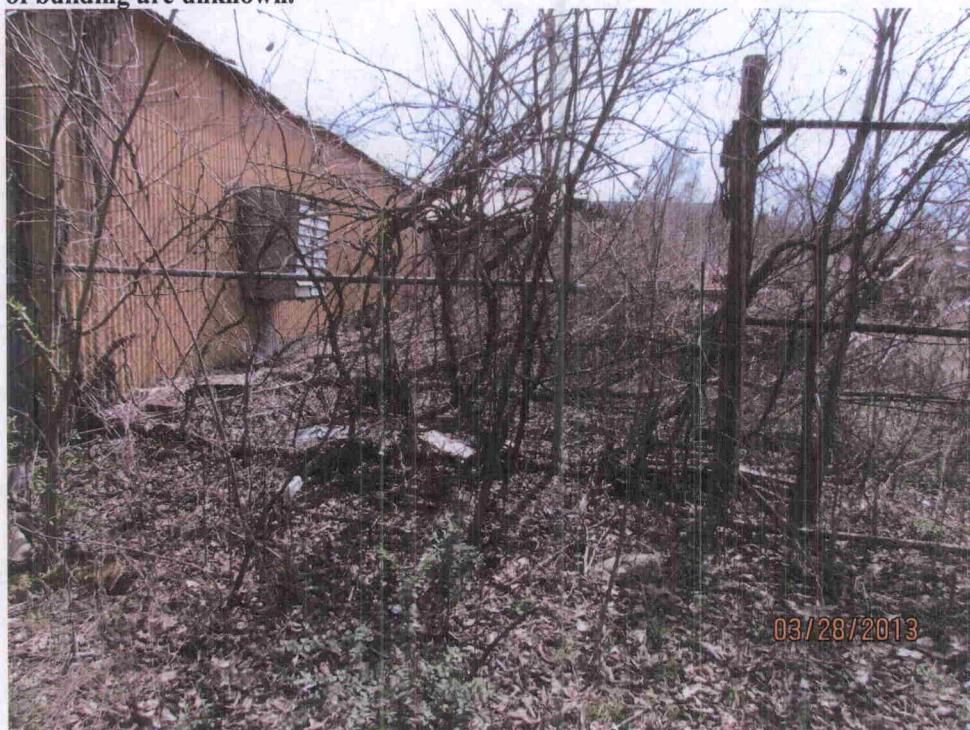
Photo # 4

Comments: View showing large gap in fencing and woody vegetation on west side of building.

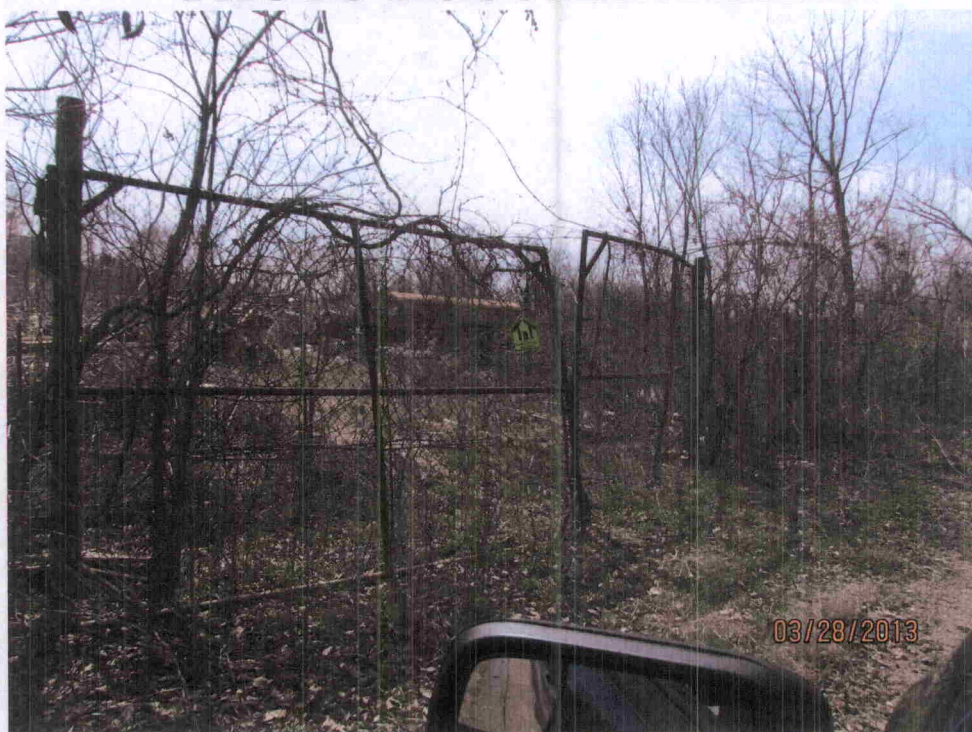
Photo # 5

Comments: View of gate on west side of building, overgrown vegetation, and various pieces of debris in background. Security sign on gate warns trespassers.

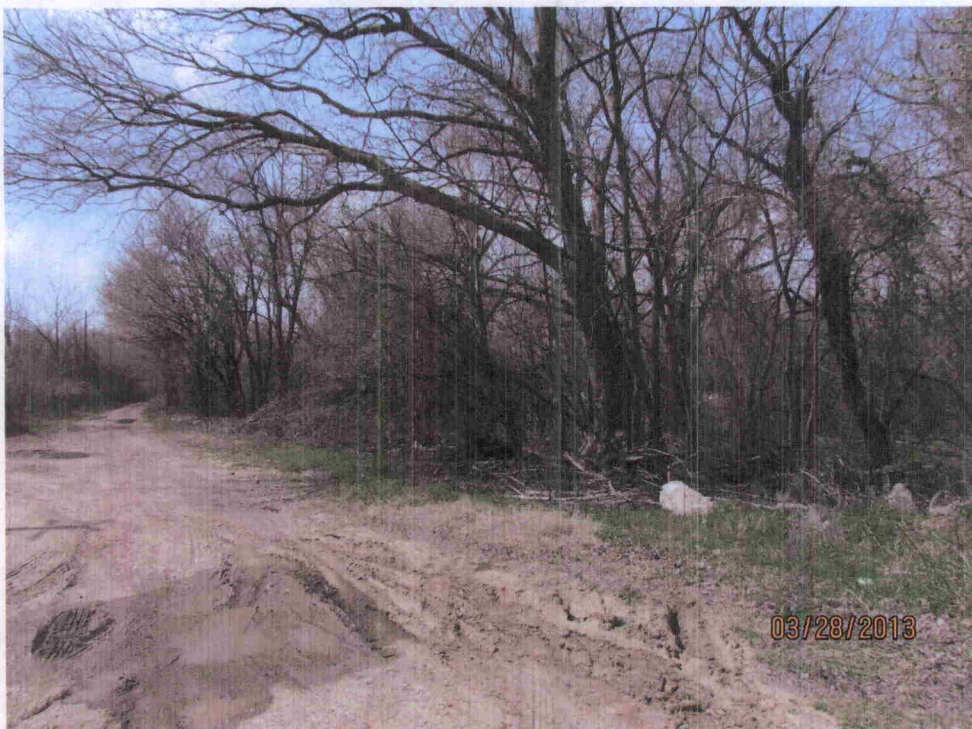
Photo # 6

Comments: View looking west showing unimproved road on flood plain on left and Coody Creek riparian vegetation to right. Note tree branches carelessly pushed against tree trunks.

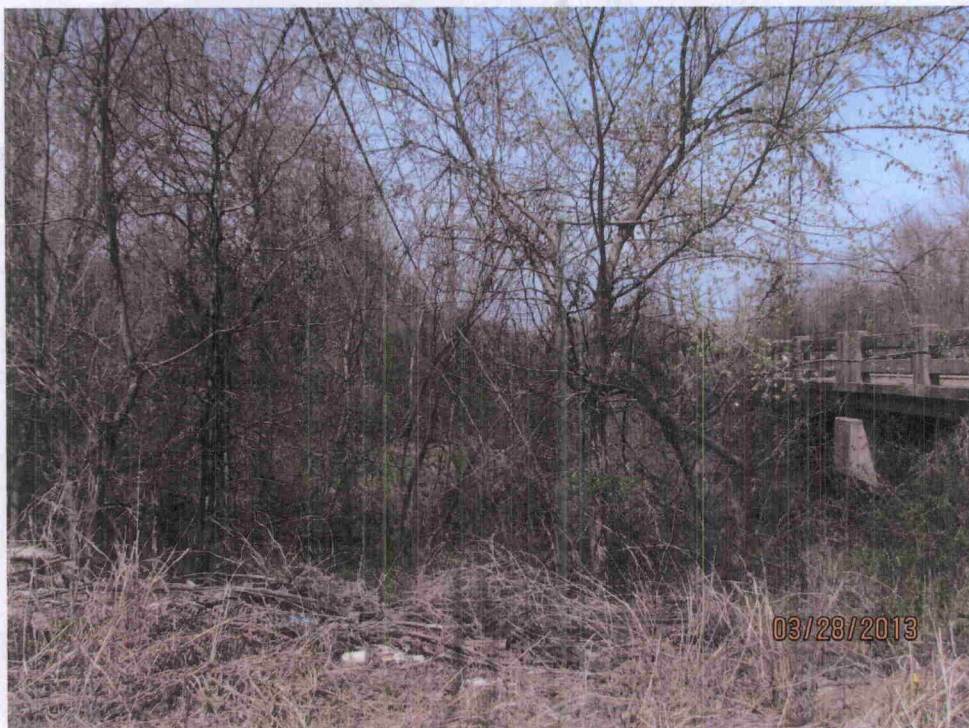
Photo # 7

Comments: View of South Cherokee Street Bridge over Coody Creek immediately north of site. Note trash among tree branches pushed off dirt road.

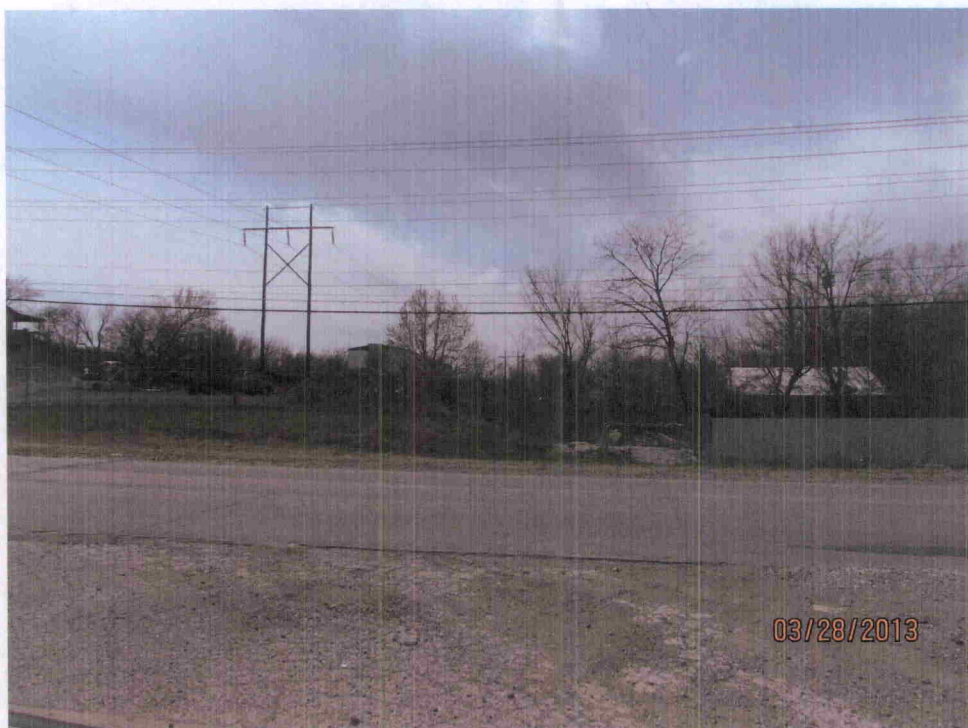
Photo # 8

Comments: View from Mobile Home Park across South Cherokee Street showing descent of hill from left to right with salvage business on left. Site is behind newly constructed white metal fence on right. Large natural gas main is immediately left of white fence.
